OPTIMIZING MARITIME INDUSTRY MANAGEMENT: AN INNOVATIVE LEAK REPAIR TECHNIQUE FOR BALLAST AND CARGO TANKS

Haryadi Wijaya^{*1)}

¹⁾ Politeknik Pelayaran Sulawesi Utara, St Trans Sulawesi, South Minahasa Regency, North Sulawesi, Indonesia

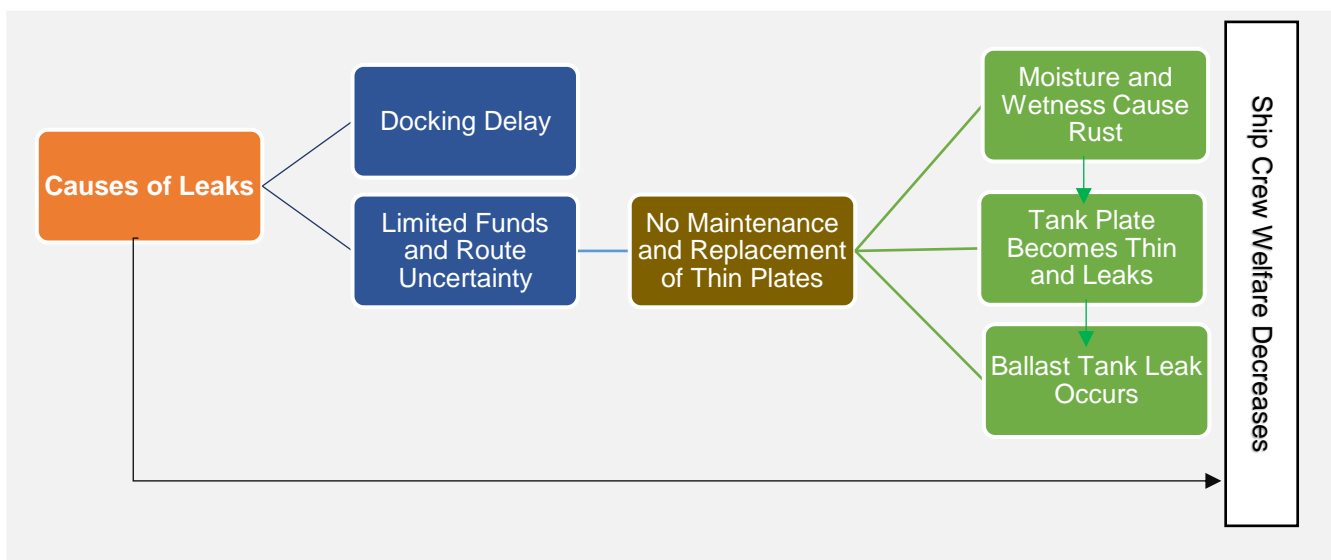
Figure 1. Causes of Ballast Tank Leaks on MT. Sepinggan Ship

First, the company's delay in docking its fleet, MT. Sepinggan, for the repair and replacement of thin ballast tank plates.

This can result in ships not undergoing regular docking and special maintenance rotations (special surveys), leading to rusting and causing the plates to become thin and leaky. The known cause of the lack of maintenance is moisture or wetness, which can be addressed with proper maintenance. With the delay in docking, perfect and thorough maintenance cannot be carried out as expected, causing this condition to persist. Iron will not rust in dry air or pure water. However, if air and water are present together, iron, especially steel, will rust quickly (Li et al., 2020; Refait et al., 2020). The rate of rusting will not decrease because the formed corrosion layer will peel off, leading to the formation of a new rust layer underneath, which will in turn release the layer above it. Therefore, if the maintenance of the keel plates and other parts of the ship is neglected, rust will accumulate, causing the plates to become thin and leaky. Based on observations, the company employs an expensive docking maintenance strategy and delays the docking schedule until a certain level of damage requires special handling. In this case, the company aims to minimize operational costs in operating its ships to maximize profits. However, since the maintenance standards applied are not optimal, the company's goal of maximizing profits cannot be realized. As the company aims to maximize profits, the welfare of the ship's crew cannot be improved and may even decline.

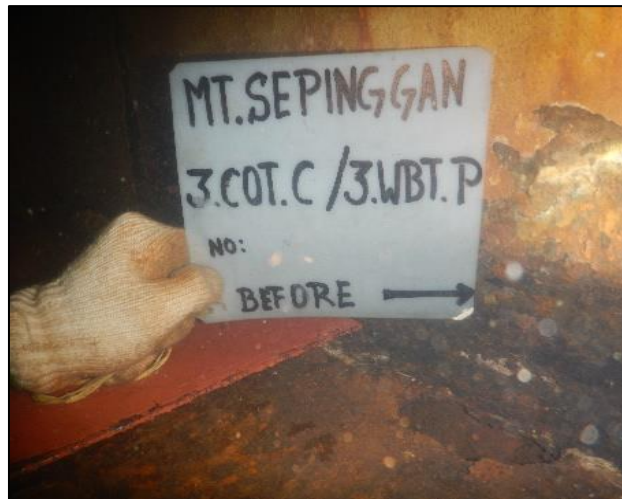
They were handling the leakage of the ballast tank in MT. Sepinggan is done by patching a new iron plate adjusted to the length and width of the leaking plate section. If a leak occurs in the ballast tank, with the crew's knowledge, skills, and expertise, it is expected that they can complete tasks and solve problems on the ship. Therefore, having an educated and experienced crew to take quick and precise actions is highly hoped and demanded.

Figure 2. Leaking Ballast Tank

The crew's actions when the ballast tank and cargo tank No. 3 left MT. SEPINGGAN experienced a leak: (a) Preparing materials: Iron Plate, Rubber Packing, Cement, Sand, Caustic Soda, Putty, Aqua Sealer, and Oil Dispersant. (b) Preparing equipment: Electric Welding Machine, Shovel, Cement Spoon, Bucket, Hammer, Fan/Blower, Lamp/Flashlight. (c) Safety Meeting: The Safety Meeting is conducted to support the safety of the MT. SEPINGGAN crew in repairing the leak on the ballast tank plate and cargo tank No. 3 left. Safety can be achieved if the factors were causing work accidents during the repair process on the ballast tank plate and cargo tank no. Three left are known, so it can be determined what steps should be taken to avoid them. The Safety Meeting can create cooperation on the ship, so work can operate smoothly and safely.

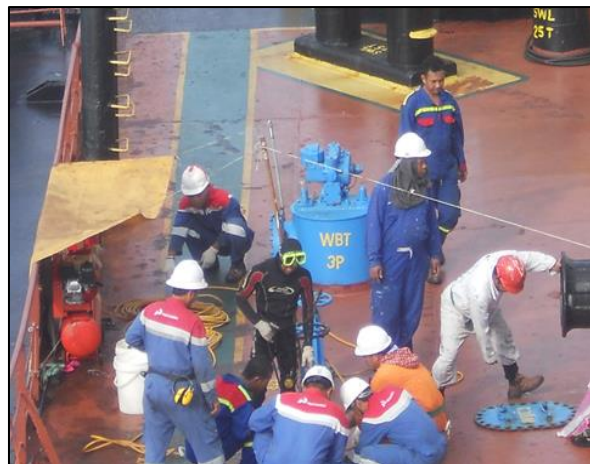
Figure 3. Welding Process

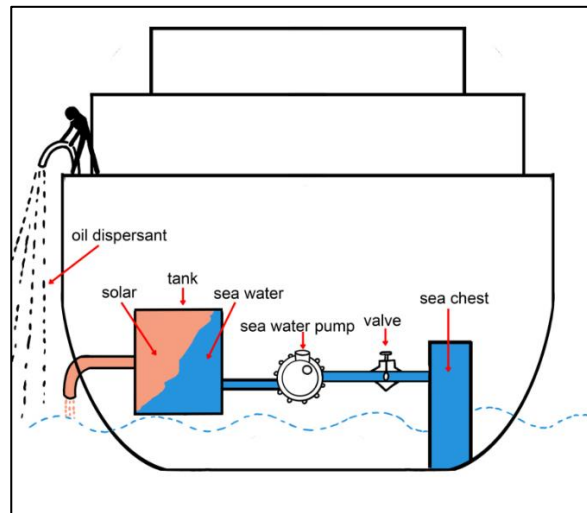
Figure 4. Working Procedures for Patching Techniques

Once the leak location is found, it is patched with putty. The Chief Officer, who has exited the tank, orders a mixture of cement, sand, and caustic soda to be prepared, evenly mixed with water, and stirred until smooth. After stirring, the cement mixture is lifted into the tank using a bucket. The mixture is then placed on the leaking plate and pressed with rubber packing to prevent further seepage, and the surrounding area is dried. A mold is then made using a new iron plate, adjusted to the length and width of the leaking plate section. This new iron plate is pressed over the rubber packing and welded around its edges using an electric welding machine by the bosun and pump man after the left ballast plate no. three are welded using an electric welding machine, the water in

the ballast tank no. three is pumped out, and the area around the leak is cleaned with a scraper and dried. The prepared cement mixture in the bucket is then poured around the edges of the newly welded plate to reinforce the patch. The mixture is monitored until it hardens, after which an aqua sealer is applied over the cement mixture around the edges of the newly welded plate. Thus, the leak patching is completed, and the manhole can be closed again. The patching using this technique is strong enough to last for several months.

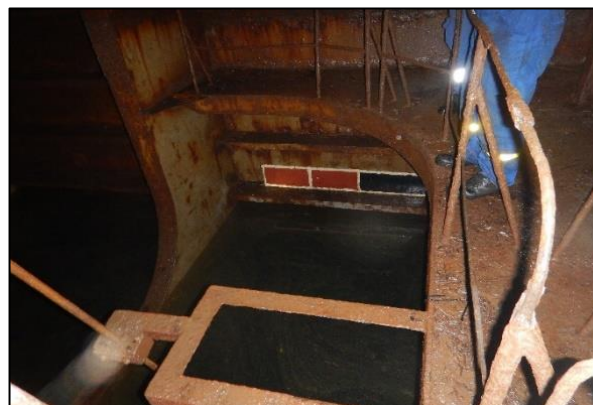
Figure 5. Welding Results
